Nailed it!!! Direct Penetrating Wounds to the Horse's Foot

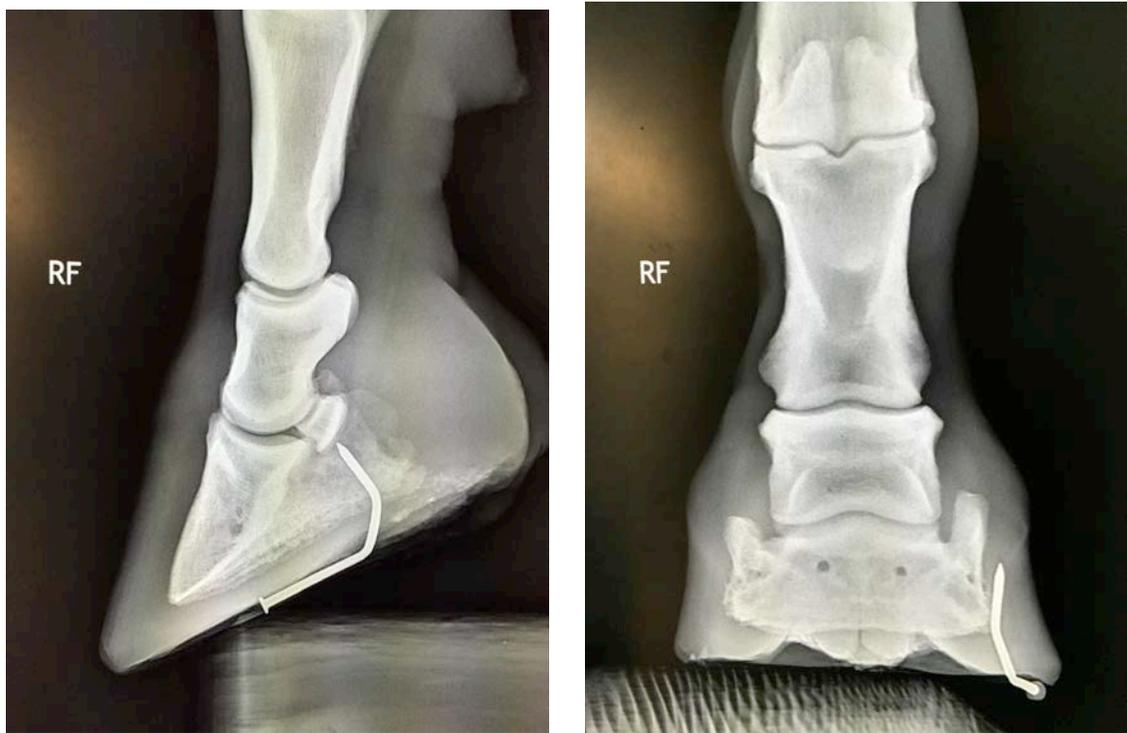
Below are radiographs of two separate cases involving direct penetration wounds to the foot. Case 1 shows a nail that on the lateral view appears as though it is contacting the navicular bone and bursa, as well as the deep digital flexor tendon. However, when examining the dorsopalmar view, the nail is actually on the medial aspect of the sole, entering along the white line, giving this horse a good prognosis pending no complications. Case 2 shows a more complicated scenario, where the screw has penetrated into the frog and has made contact with the coffin bone. This horse underwent surgical treatment followed by intense post-operative care involving intravenous antibiotics and analgesics, regional limb perfusions, and antibiotic infused gauze packing in the solar defect as well as a hospital plate.

Case 1. Lateral and dorsopalmar views of the right front foot.

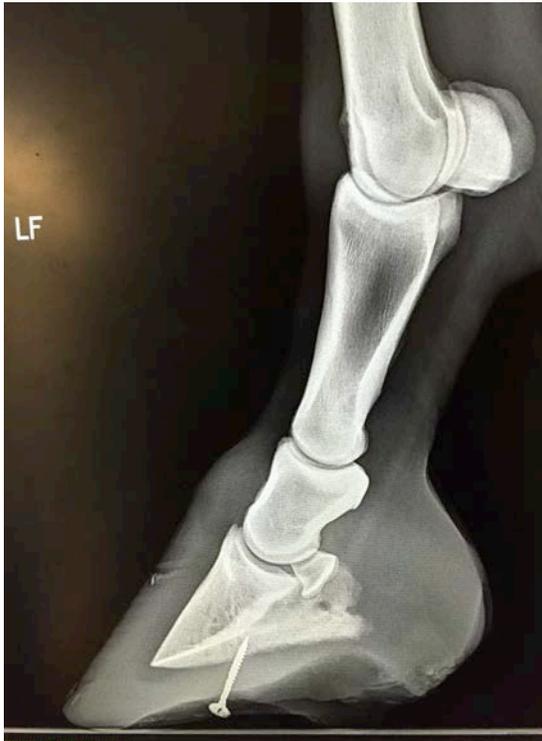
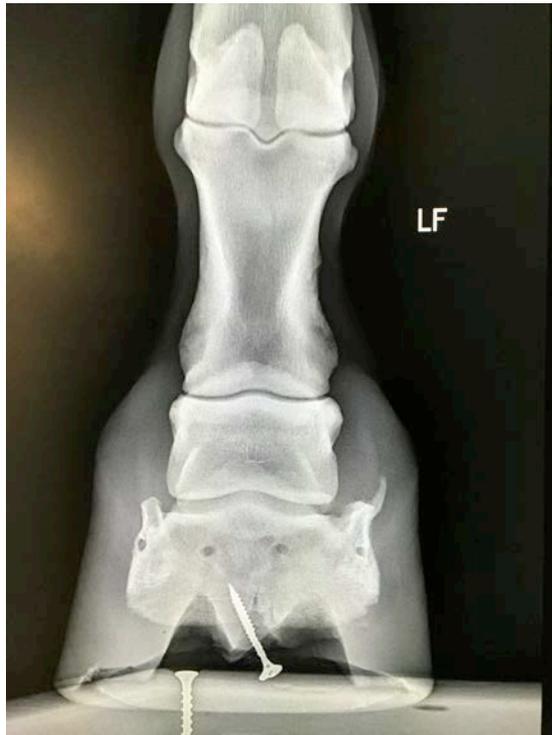
Case 2. Lateral and dorsopalmar views of the left front foot.
